Manhole Inspection Summary

Manhole # S39G__055MH

Insp Date: **5/5/09 1:09 PM**

Location Address: **835 E LOMBARD ST**

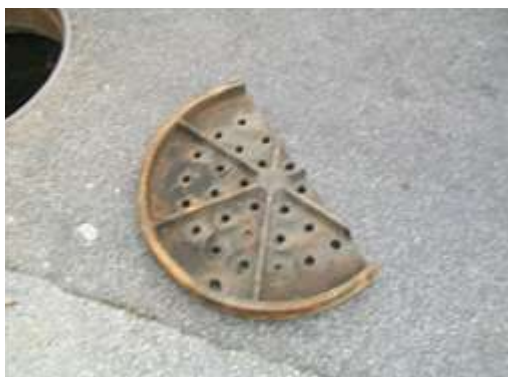
MISC.

Comments **CUT OFF STORM COVER TO COMPLETE INSPECTION, RELPACED WITH SANITARY COVER.**

CUT OFF VENTED STORM DRAIN
COVER AND REPLACED WITH
STANDARD SANITARY

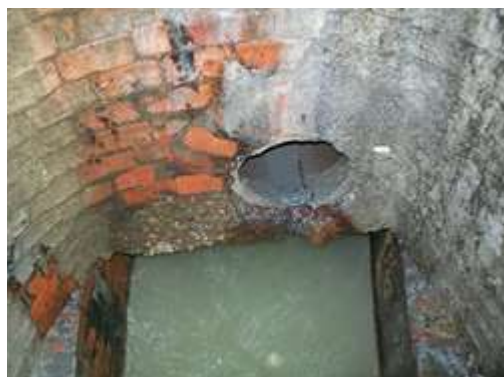
Defect 4

☒ **Wall**

INFILTRATION @ BARREL WALL

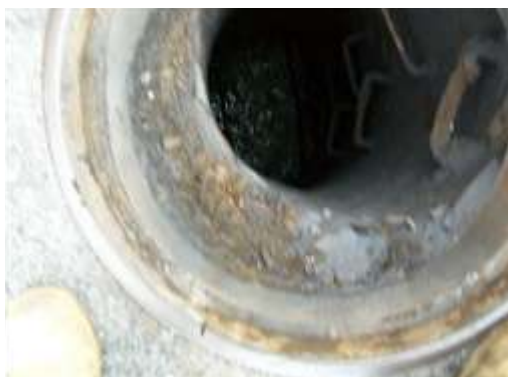
Defect 3

Offset: **4** (in.)

FRAME OFFSET

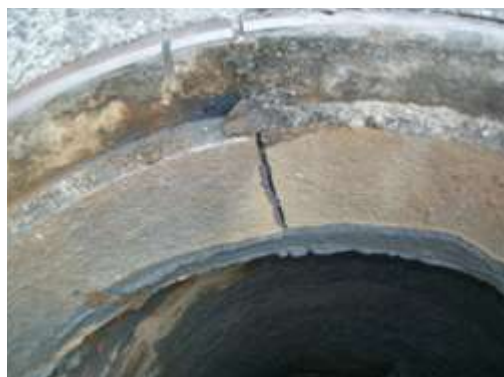
Defect 2

☒ **Cracked**

CRACKED/FRACTURED FRAME

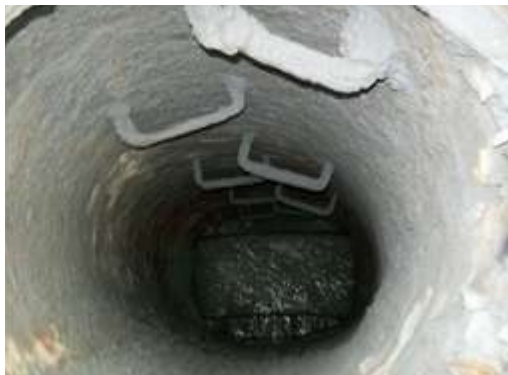
Defect 1

☒ **Corroded**

CORRODED STEPS

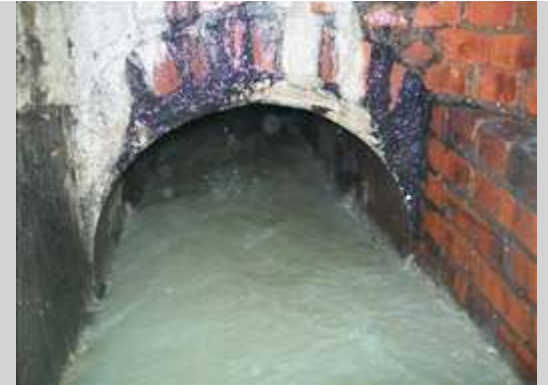
12 O'Clock Outflow

24 in. Circular Gravity Sewer
Pipe Out @ 12 O'Clock

Pipe Height: **24** (in.) Rod and Bar (Angled)
Pipe Material: **Clay** ☐ Pipe Lined
Invert Depth: **15.40** (ft.) Flow Characteristics: **Fast**
Deposits: ☒ None ☐ Mud ☐ Sludge ☐ Debris ☐ Grease
Silt Depth: **0** (in.) Deposits Extent:
Infiltration: **Weeper** Pipe Seal Cond: **Sound**

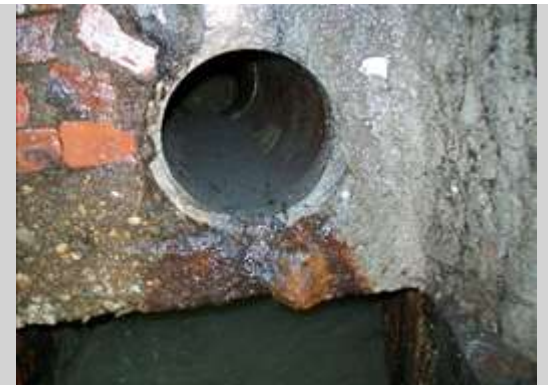
6 O'Clock Inflow

8 in. Circular Gravity Sewer
Pipe In @ 6 O'Clock

Pipe Height: **8.4** (in.) Rod and Bar (Angled)
Pipe Material: **Clay** ☐ Pipe Lined
Invert Depth: **13.10** (ft.) Flow Characteristics: **Slow**
Deposits: ☒ None ☐ Mud ☐ Sludge ☐ Debris ☐ Grease
Silt Depth: **0** (in.) Deposits Extent:
Infiltration: **None** Pipe Seal Cond: **Sound**

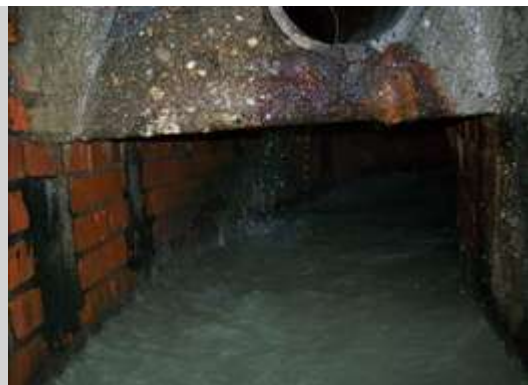
6 O'Clock Inflow

24 in. Circular Gravity Sewer
Pipe In @ 6 O'Clock

Infiltration: **Runner** Pipe Seal Cond: **Unknown**
